Manhole Inspection Summary

Manhole # **S17C__007MH**

Insp Date: **2/28/08 1:01 PM**

Location Address: **REAR OF 2401 EDMONSON AVE** Cross Street: **BENTALOU ST**

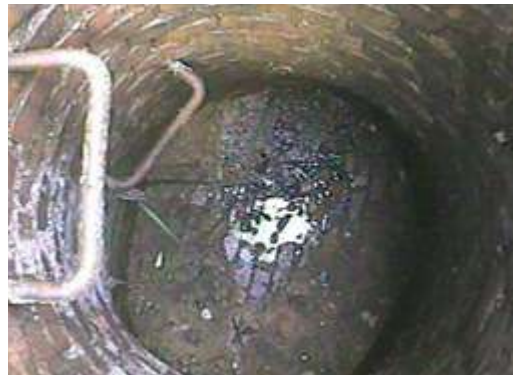
Defect 1

Steps Count: **3** Missing: **1** ☒ **Corroded**

STEPS CORRODED

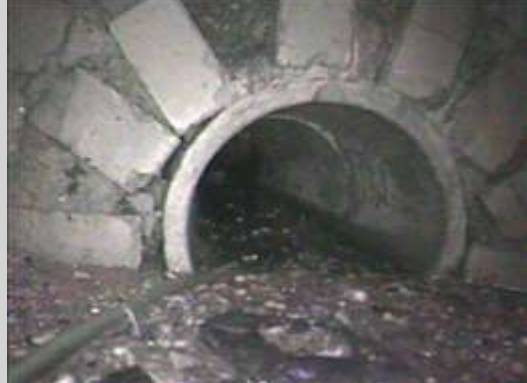
12 O'Clock Outflow

8 in. Circular Gravity Sewer
Pipe Out @ 12 O'Clock

Deposits: ☐ None ☐ Mud ☐ Sludge ☒ **Debris** ☐ Grease

Silt Depth: **2** (in.) Deposits Extent: **Medium**
